Mitigation best practices

Quick reopening of supermarket served Galveston citizens

Seawall, structural measures, last-minute prep protected Kroger

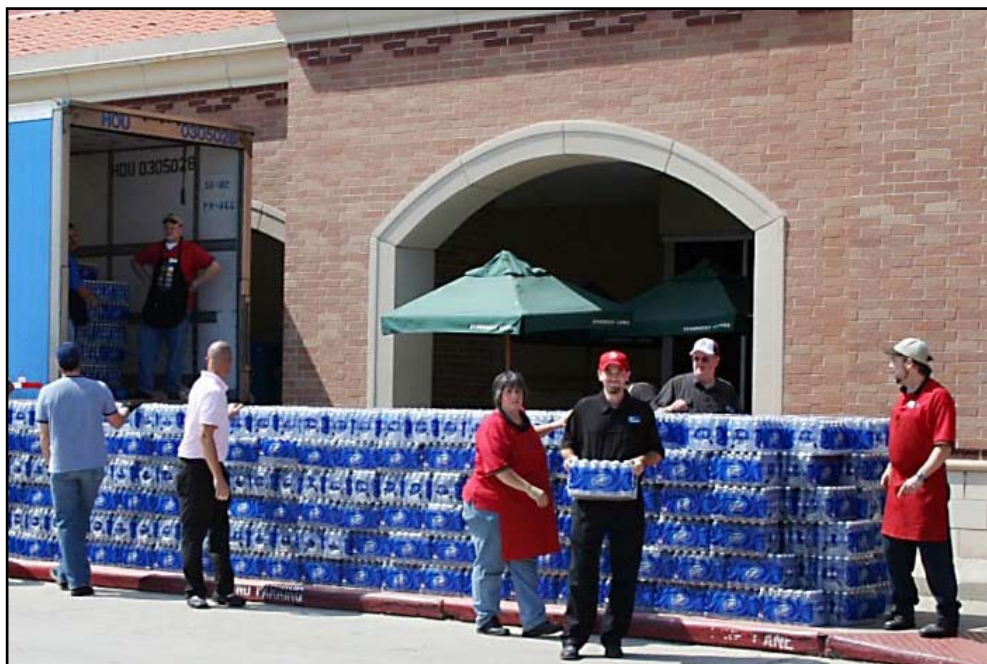
Kroger's grocery in Galveston opened quickly after Hurricane Ike because of hazard-mitigation actions.

Hearing explained that the store, built in 2000, “was designed to have water roll to the left and the right, so the store wouldn’t be impacted so much.”

He also said, “When they built this store, they brought in extra fill to raise the lot, built up more on a concrete pad and raised the store quite a bit. We have a disaster plan, but everything hinges on the physical structure of the building, whether anything survives or not.”

The sturdy masonry structure complied with all building codes when the structure was built, said David Ewald, City of Galveston building official. In fact, the structure was built more than two feet above the height required by floodplain regulations, according to Kroger officials.

Kroger’s staff conducted a blitz of preparedness activities before the storm hit. “We had shutters on all our windows — which were already protected by a masonry-columned promenade — sandbagged the doors and put heavy pallets of merchandise on our bay doors to keep them from blowing in,” Hearing said. “What we did is like the normal precautions you would do at your house before a storm, but on a little larger scale.
